EXPERIMENTS TO DETERMINE DEBRIS FORMATION
FROM CORRUGATED STEEL AND BRICK WALLS

Final Report

January 1970

URS RESEARCH COMPANY

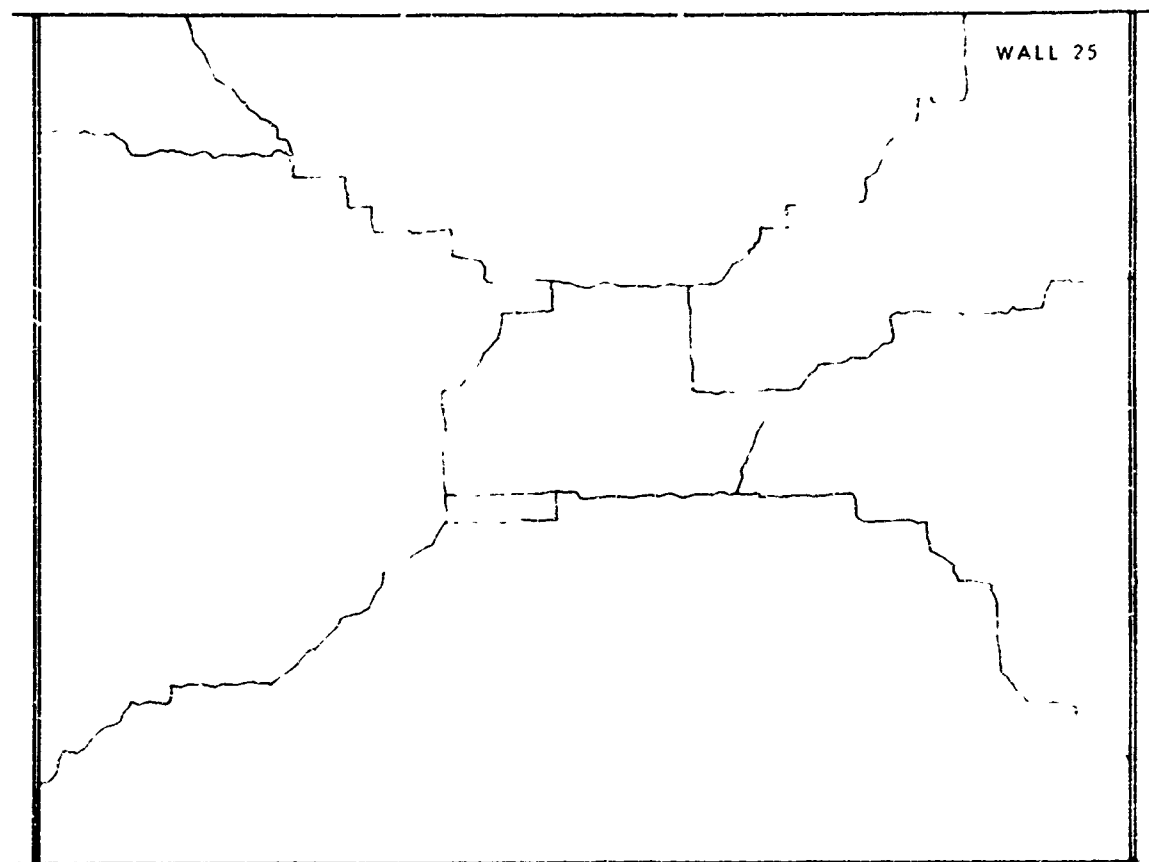
Results: Wall cracked as shown in sketch below but did not collapse.

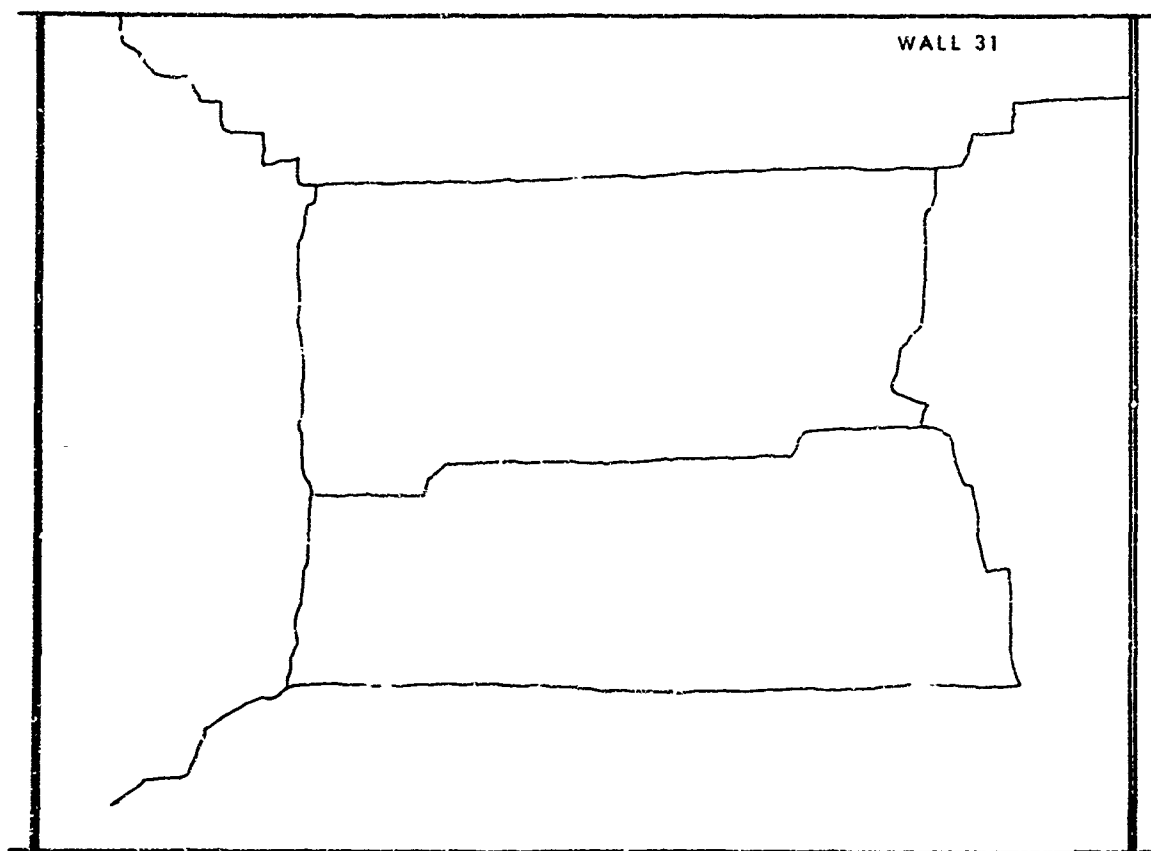
Results: The wall failed. (See initial crack pattern sketch.)
